INDOOR AIR POLLUTION MIGRATION TRANSPORT MECHANISMS
IN HIGH-RISE BUILDINGS

This engineering case treats an indoor air pollution problem that occurred in a high-rise building. It illustrates the air migration problems that exist within high-rise buildings which can act as transport mechanisms for buoyant air pollutants. It also demonstrates some of the air engineering methods that can be applied to prevent or inhibit such migration problems.

John W. Fothergill, Jr.
Integrated Systems, Inc.
(a Maryland corporation)
P. O. Box 128
Brunswick, MD 21716

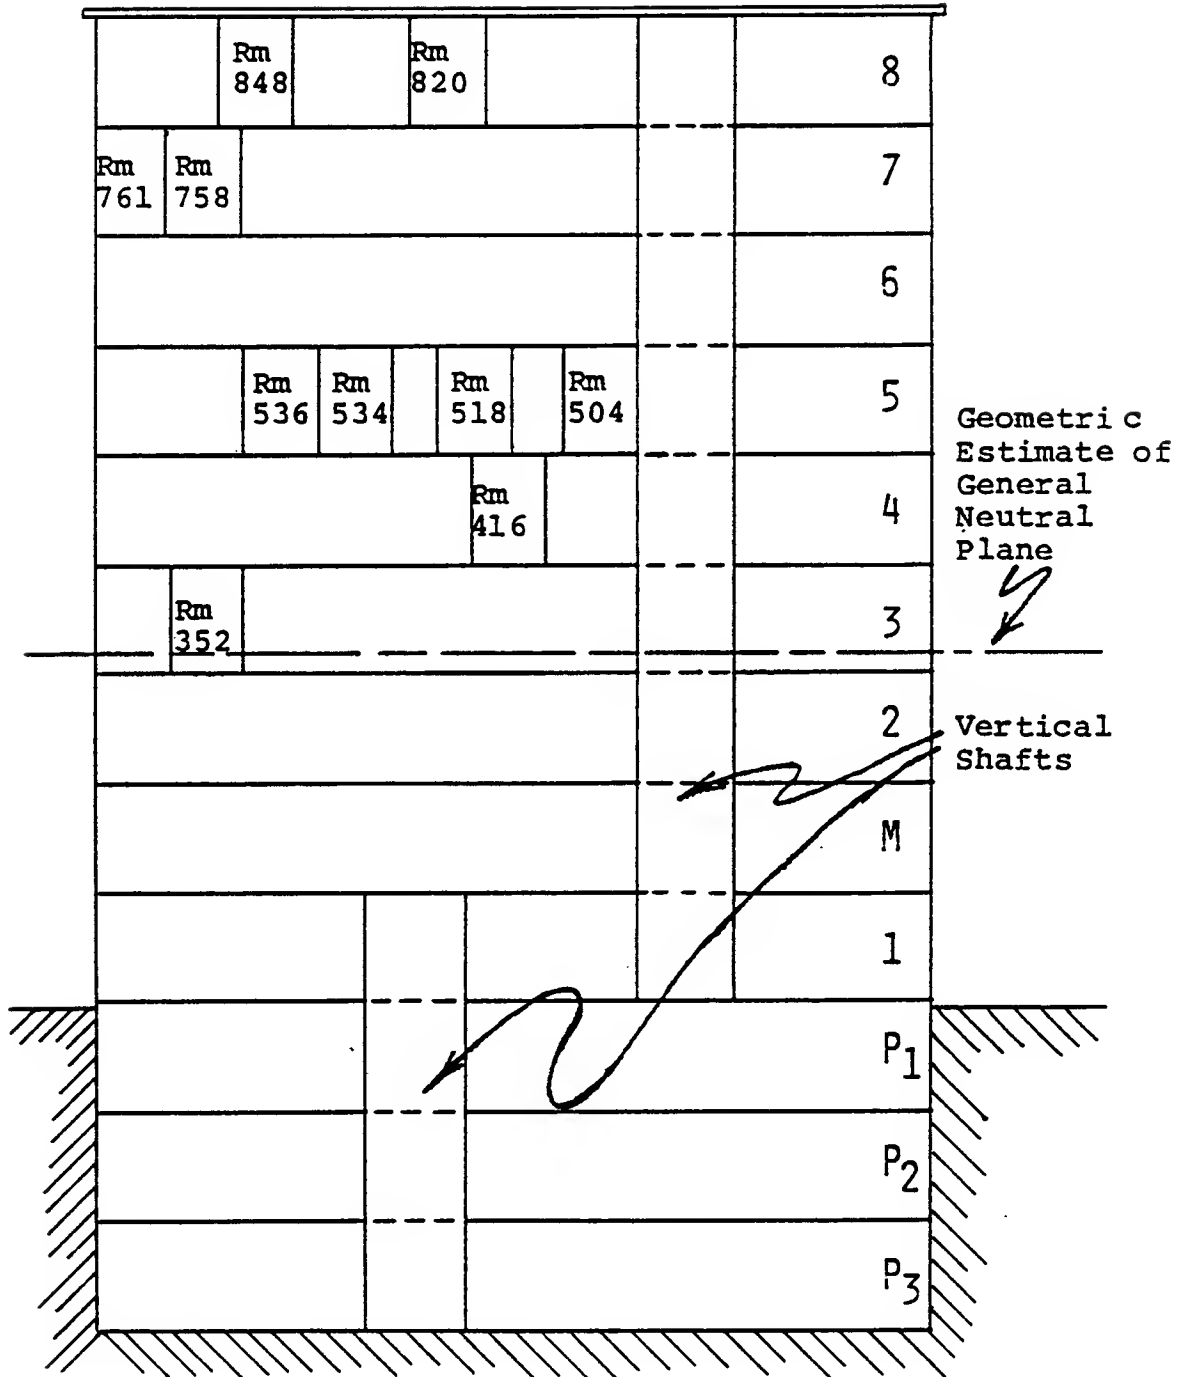
FIGURE 1. VERTICAL DISTRIBUTION OF COMPLAINT SPACES

Initially, these complaints were primarily about a "dust problem." Subsequently, the complaints took the form of eye irritation, nose bleeds, sore throats and respiratory problems. Reports of "dead" air in some areas were also received. Included with many of these complaints was mention of cooked or cooking food odors. The odor complaints were reported as being the worst on the 5th

floor. They were also reported as being of a continuous nature on the 5th floor.

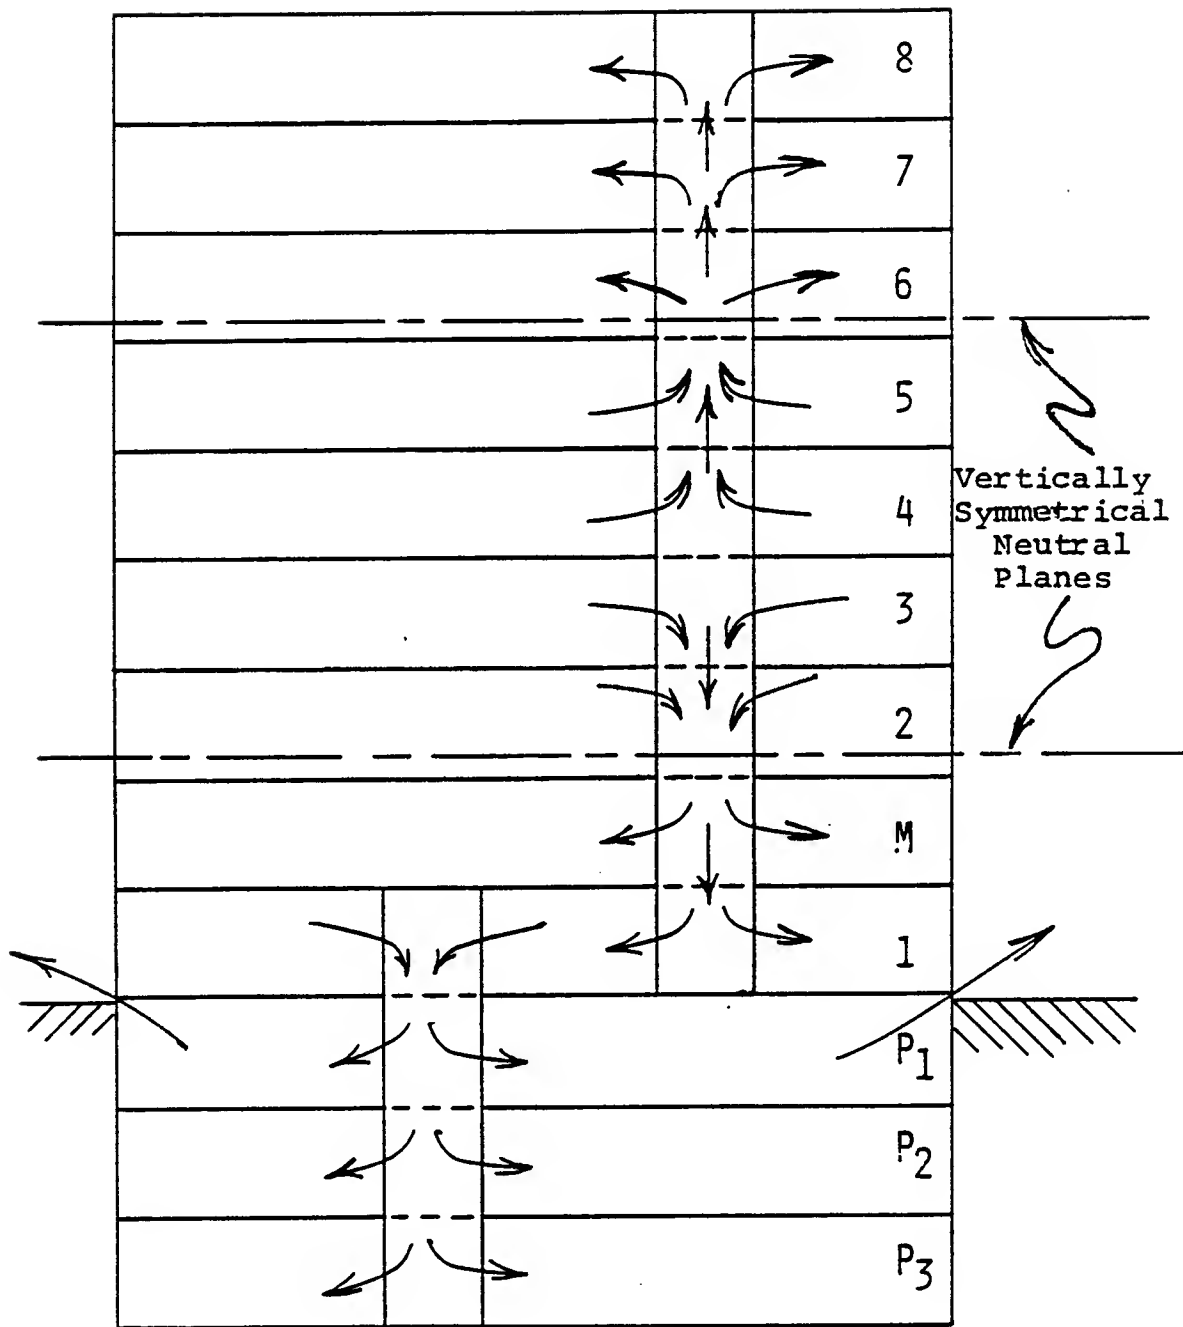
FIGURE 2. THEORETICAL SUMMER OR WARM SEASON VERTICAL AIR MIGRATION BEHAVIOR DUE TO THERMAL BUOYANCY

The leakage flow behavior evidenced in the acquired data, as illustrated in Figure 5, comes very close to the theoretical behavior presented in Figure 2 for summer conditions. The data for above grade stairwells #2 and #4, which are shown in Figure 5, definitely reflect the flow behavior illustrated in Figure 2. The switching of flow direction in these stairwells appears to occur at the 5th floor level, with two neutral planes occurring. The upper neutral plane appears to occur in the vicinity of the 6th or 7th floors and the lower neutral plane appears to occur in the vicinity of the deck of the 2nd floor. Figure 5 also presents estimates of the volume flow rates, which were calculated from the acquired data using Equations 1 and 3 of Appendix B.

The theoretical behavior shown in Figure 2 assumes that everything is symmetrical, equivalent and balanced. However, these conditions do not exist in the USIA headquarters building and the results implied by the measured data reflect these differences. In general, other than the typical construction variations and lack of balancing in the HVAC system, there did not appear to be any large or significant cause for the migrational air flow through the stairwells in the USIA building to be different than that which should be expected.

The failure of the chemical approach to detect significant levels of any target pollutants during August also tends to reinforce the summer air migration behavior illustrated in Figure 2. If this same investigation were repeated under cold winter conditions, completely different results would quite likely be determined.

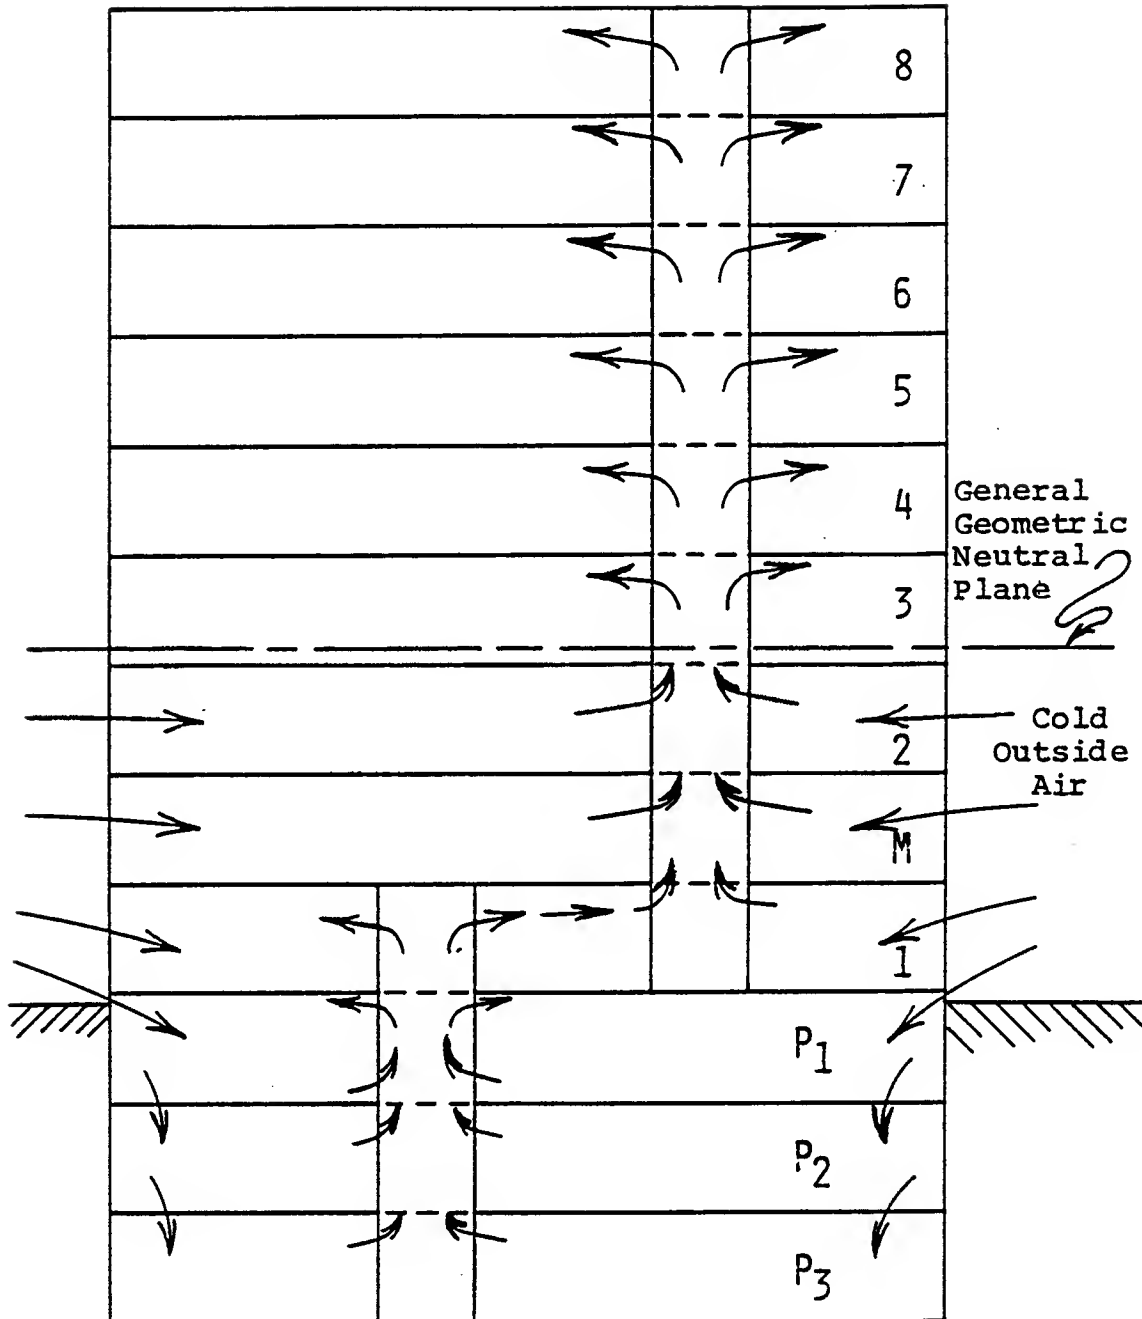
FIGURE 3. THEORETICAL WINTER OR COOL SEASON VERTICAL BEHAVIOR DUE TO THERMAL BUOYANCY

1. That winter leakage flow behavior would be as illustrated in Figure 3.
2. That the average above grade stairwell air temperature is 60°F.
3. That the average building corridor air temperature is 70°F.
4. That the stairwell-corridor doors have an average leakage area of 0.2 square feet.

The estimated air leakage through the stairwell-corridor doors under the above conditions ranges from 31 CFM on the 3rd floor to 188 CFM on the eighth floor. These leakage flows provide transport mechanisms for buoyant pollutants from the lower levels through the stairwells to the upper levels of the building.

As in the case of the above grade stairwells, the winter leakage flow behavior of the above grade elevator shafts should be similar to that shown in Figure 3. As a result, the above grade elevator shafts would behave in the same manner as the above grade stairwells relative to providing a transport mechanism for buoyant pollutants from the lower levels to the levels of the building above the 2nd floor.

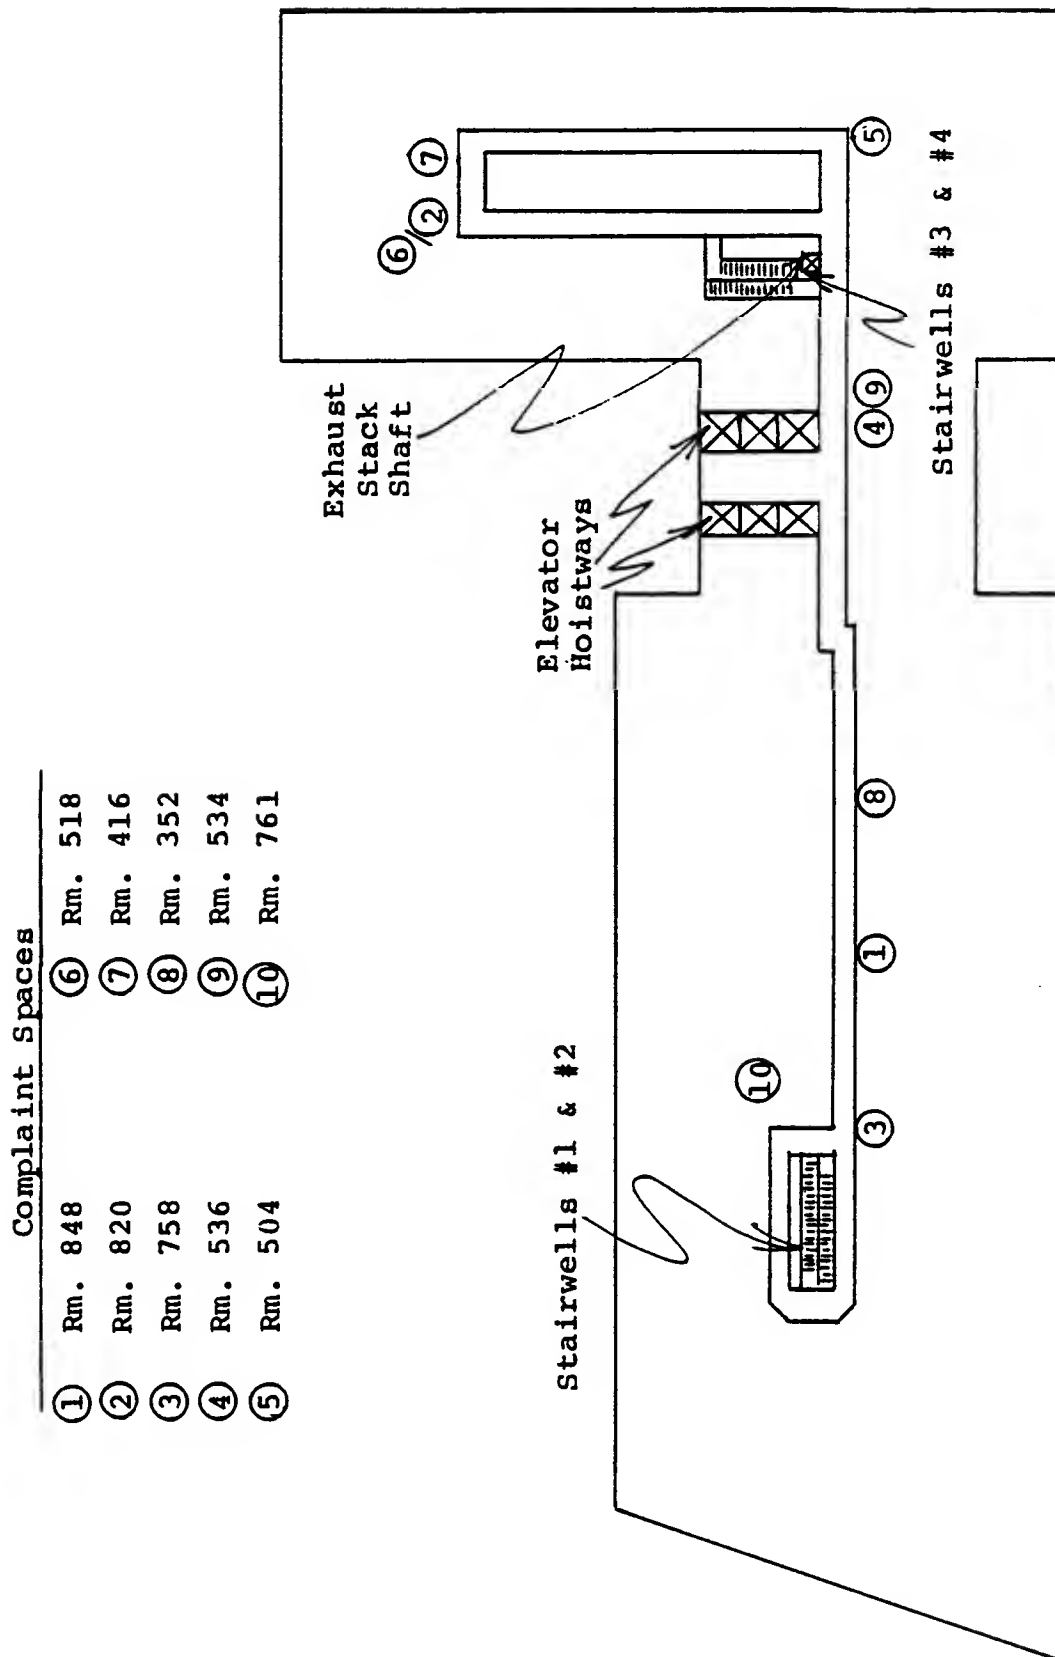
Figure 4. Horizontal Pattern of Complaint Spaces

This condition fully explains the tendency of the spaces occupied by the complainants to primarily occur near the elevator lobby and in the north wing, as shown in Figure 4. This air stream provides the horizontal migrational mechanism for each of the upper floors.

The existence of this horizontal flow implies the need for the pollutant input location on each floor, i.e., the infiltration location(s), to be upstream of the involved spaces. Table 7 of Appendix A indicates the candidate vertical infiltration routes that would satisfy the vertical and horizontal location of each of the spaces occupied by complainants. The implication of Table 7 of Appendix A is that stairwells #1 and #2, and the communications cable shaft are the most likely vertical migration routes. The above grade elevator shafts are the second most likely vertical migration routes.

In general, this unbalanced condition of the north and south HVAC systems requires correction. It must be corrected before any attempt is made to stabilize pressure relationships between occupant spaces and adjacent corridors.

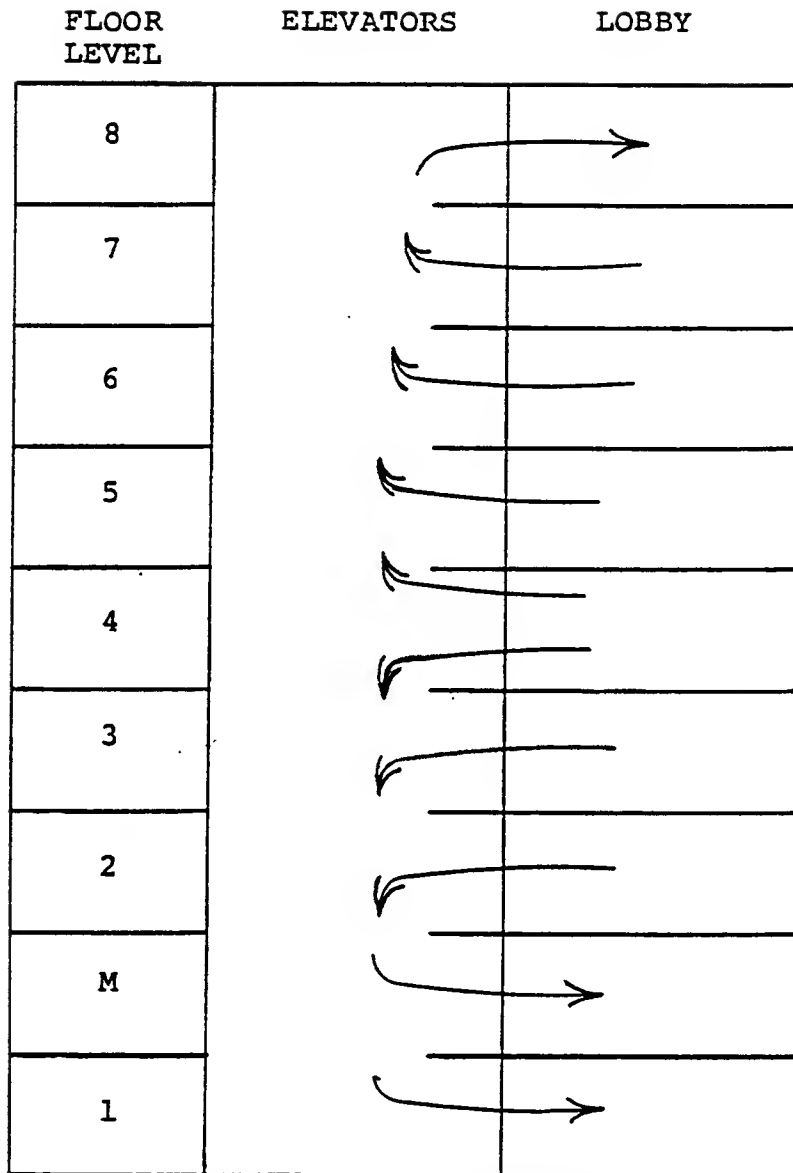
FIGURE 7. GENERALIZED AIR FLOW BEHAVIOR
IN THE ABOVE GRADE ELEVATOR SHAFTS

shafts, as illustrated in Figure 6, is very similar to that evidenced by the above grade stairwell data discussed in the previous section. Further, the elevator leakage flow behavior is almost identical to the theoretical or anticipated flow behavior shown in Figure 2, for summer conditions. In fact, the data generally imply that somewhere around the 4th floor level is where flow direction switching occurs in the elevator shafts and that two neutral planes exist in each shaft. The upper neutral plane appears to exist somewhere in the upper part of the seventh floor or the deck of the eighth floor. The lower neutral plane appears to exist in the upper part of the mezzanine or the deck of the second floor, as illustrated in Figures 6 and 7.

In general, significant migration of buoyant pollutants via these routes within the USIA Headquarters building did not appear to be possible.

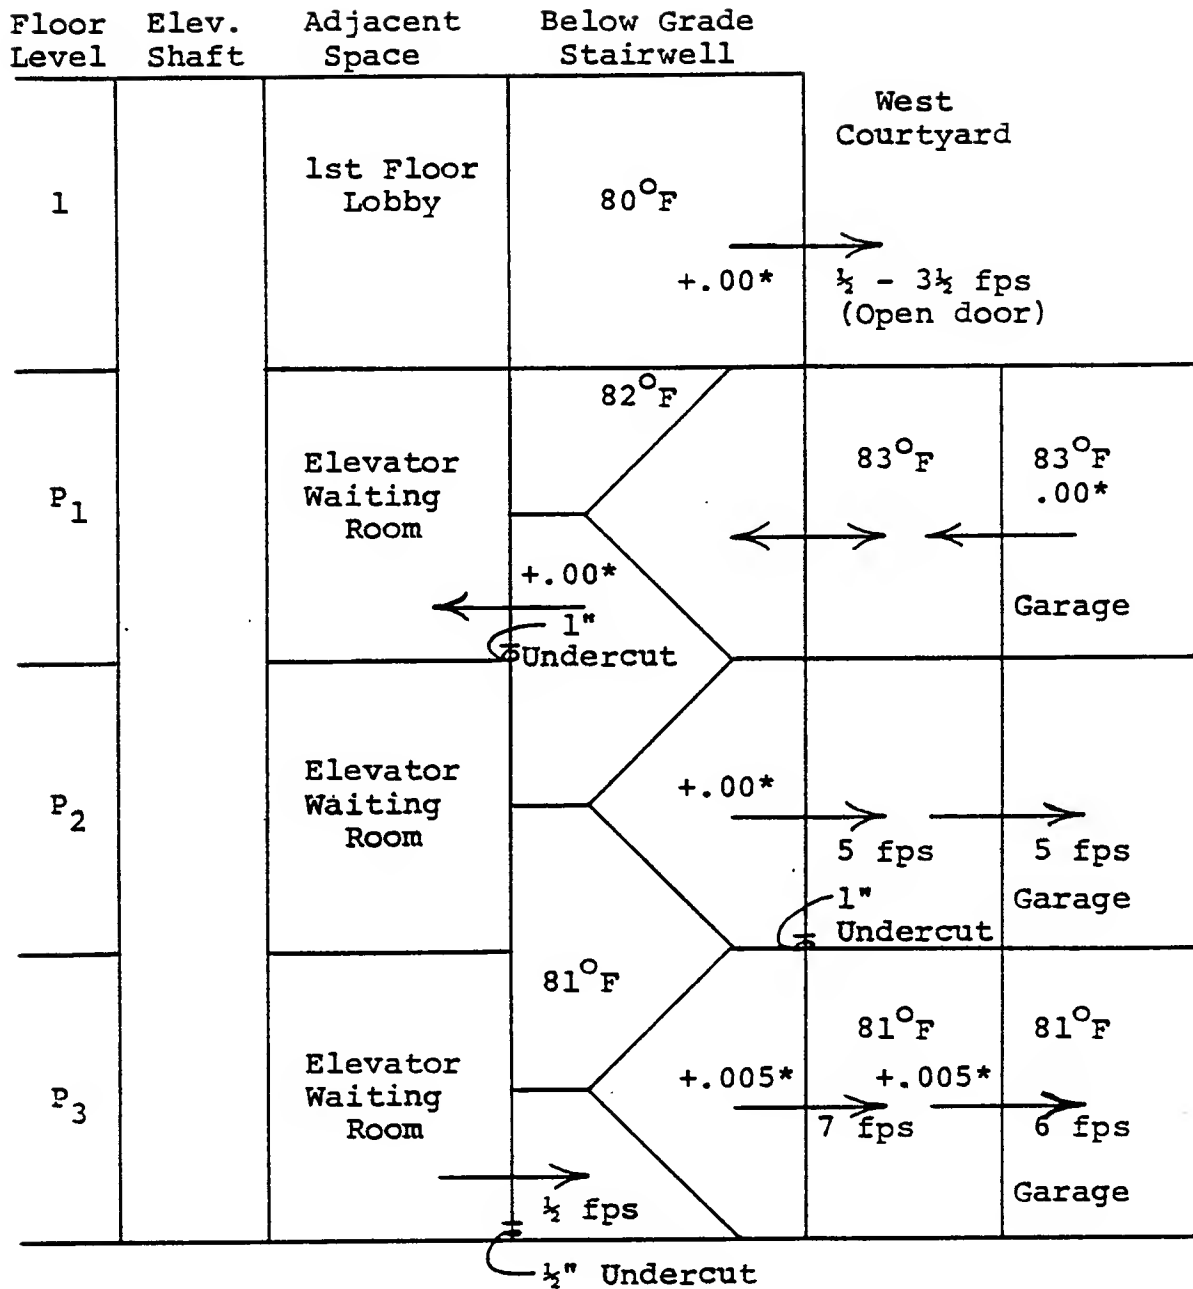
FIGURE 9. FLOW BEHAVIOR/DATA FOR BELOW GRADE
WEST COURTYARD STAIRWELL

At the time the measurements were made, the below grade stairwells were essentially in balance with the below grade garage levels, i.e., there were only very small flow rates due to thermal buoyancy forces. The temperatures within the stairwells and the garage levels were essentially the same. Under such conditions there should be very little, if any, air migration and transport of buoyant pollutants via these stairwells.

However, the measurements taken did reflect the expected behavior for summer conditions which is illustrated in Figure 2. The actual data implied flow behavior and relevant data are presented in Figure 9.

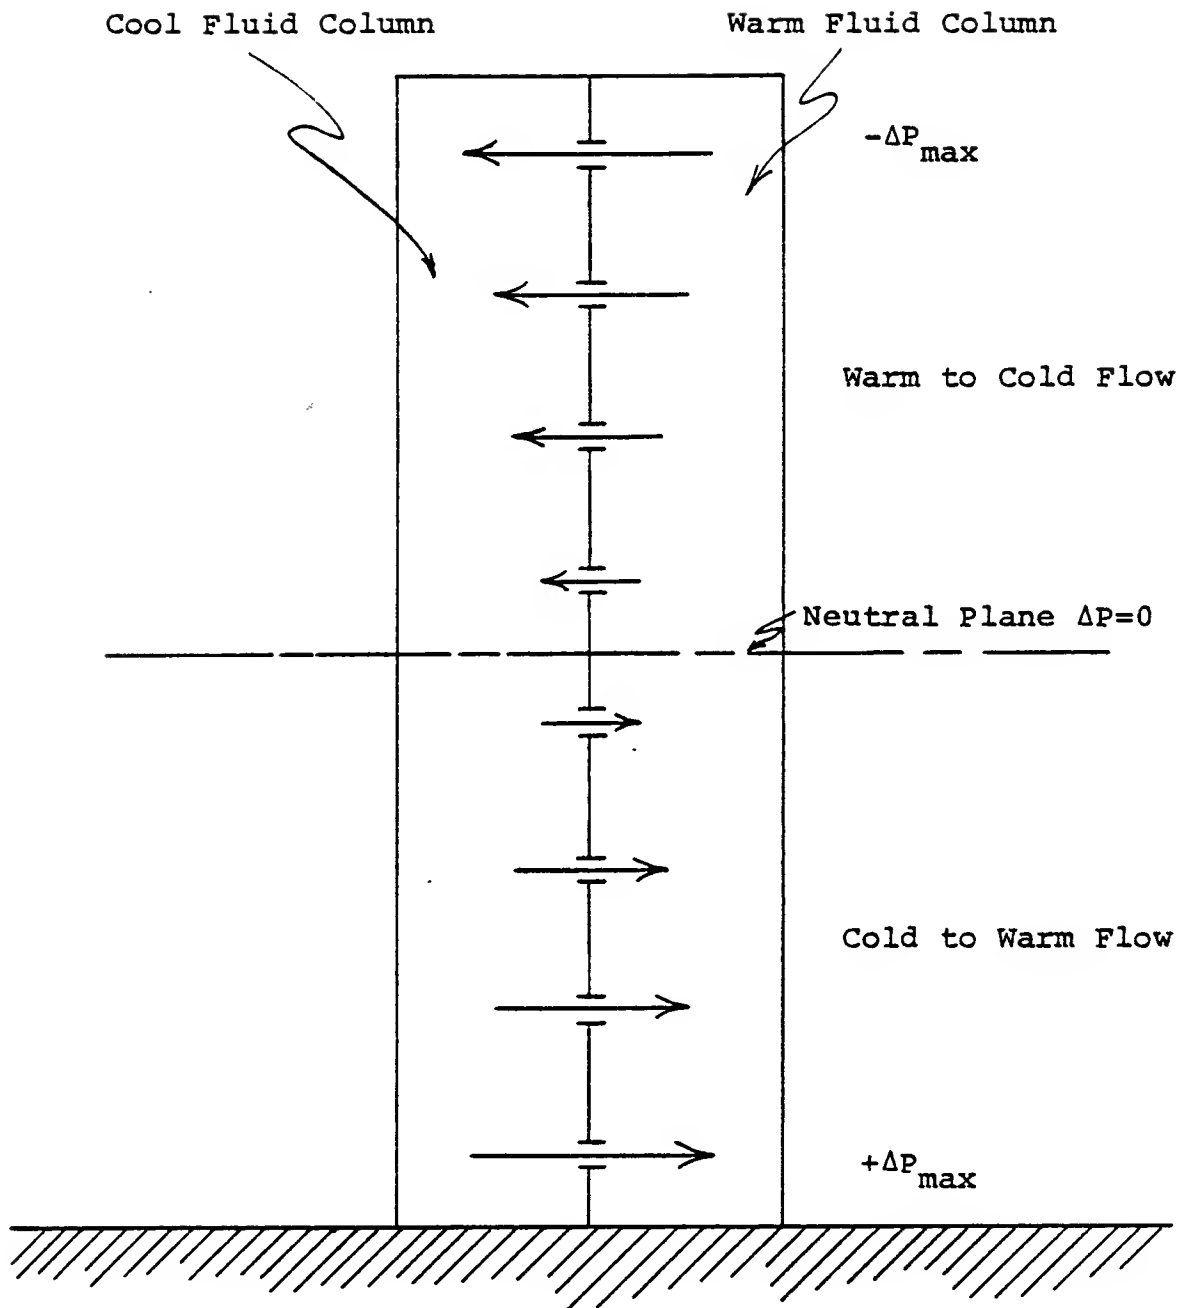
FIGURE B-1. "STACK EFFECT" FLOW BETWEEN FLUID COLUMNS
AT DIFFERENT TEMPERATURES

Given two adjacent columns of a fluid, compressible or incompressible, with significantly different temperatures and horizontal channels between such columns, thermally induced pressure differentials will exist that cause flow from one column to the other, as long as the temperature differences remain. The lower section of the cooler column will flow into the warmer column, and the upper section of the warmer column will flow into the cooler column, as illustrated in Figure B-1. The pressure

differentials are maximum, equal and opposite at the extreme ends of the columns, if the geometry of the columns is symmetric. If the columns and the connecting channels are vertically symmetric, the pressure differential at the mid-height of the columns will be zero. This point is usually referred to as the neutral plane because all points in a plane passing through both columns at this point are at the same pressure. If the columns are not vertically symmetric, the neutral plane will exist at a point unique to the column pair and away from the mid-height position of the columns.
